Summary of PS Module Irradiation

K. Einsweiler, LBNL

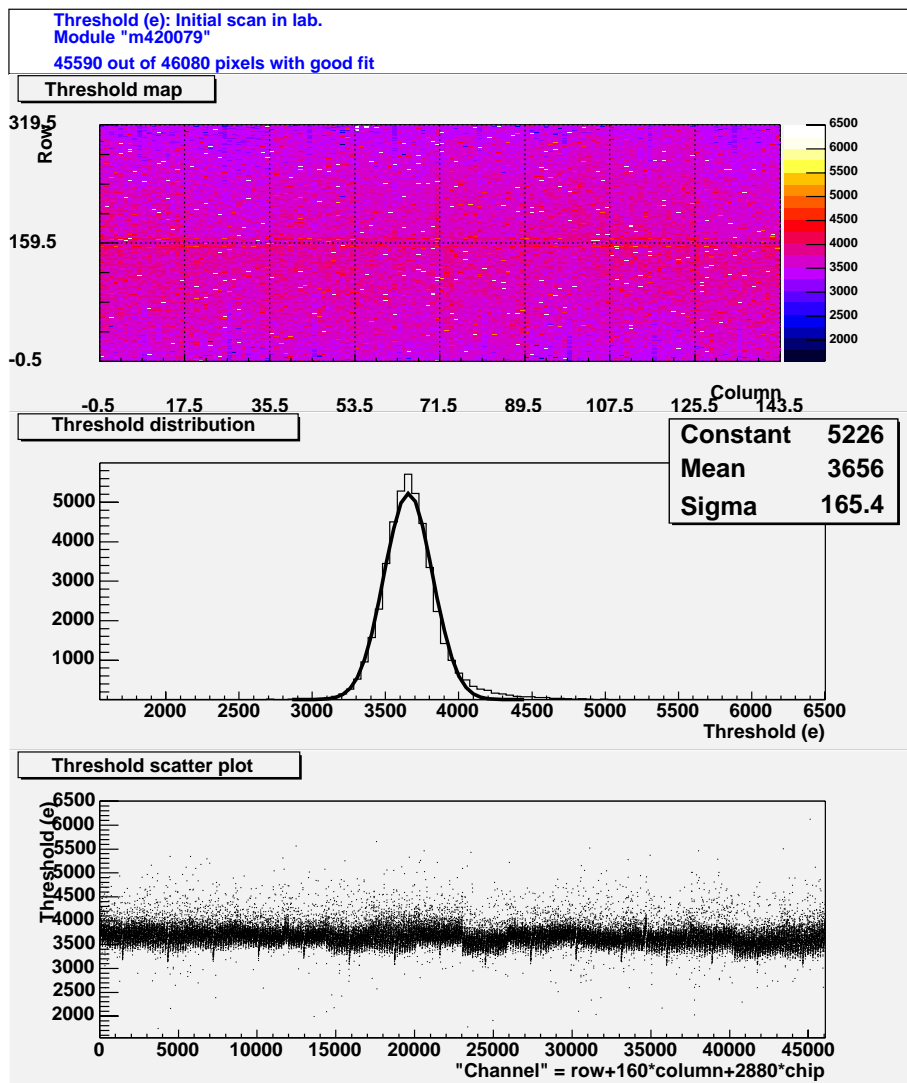
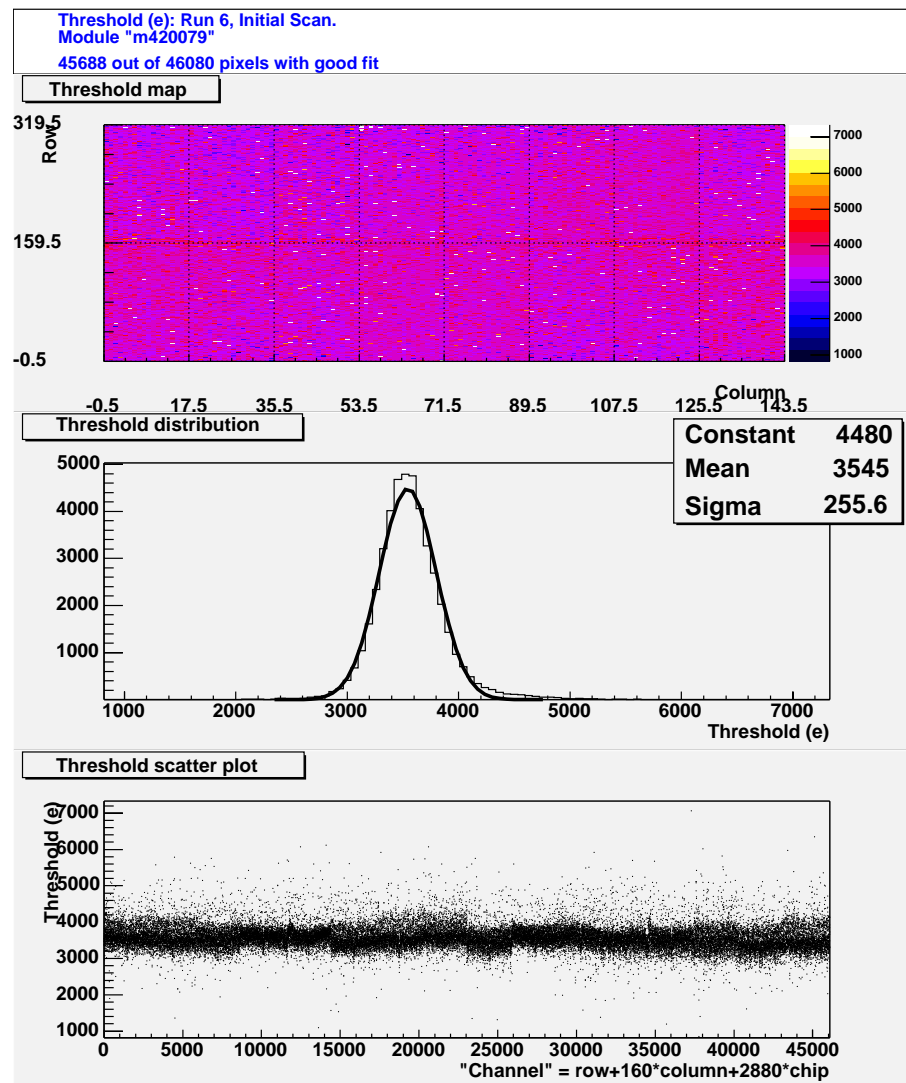
- Initially, all modules were tuned at room temperature, with good dispersion. Some modules had both TDAC and FDAC tuned. Operation at -7C increased the threshold dispersion (left is in LBL lab, right is with box installed in T7):

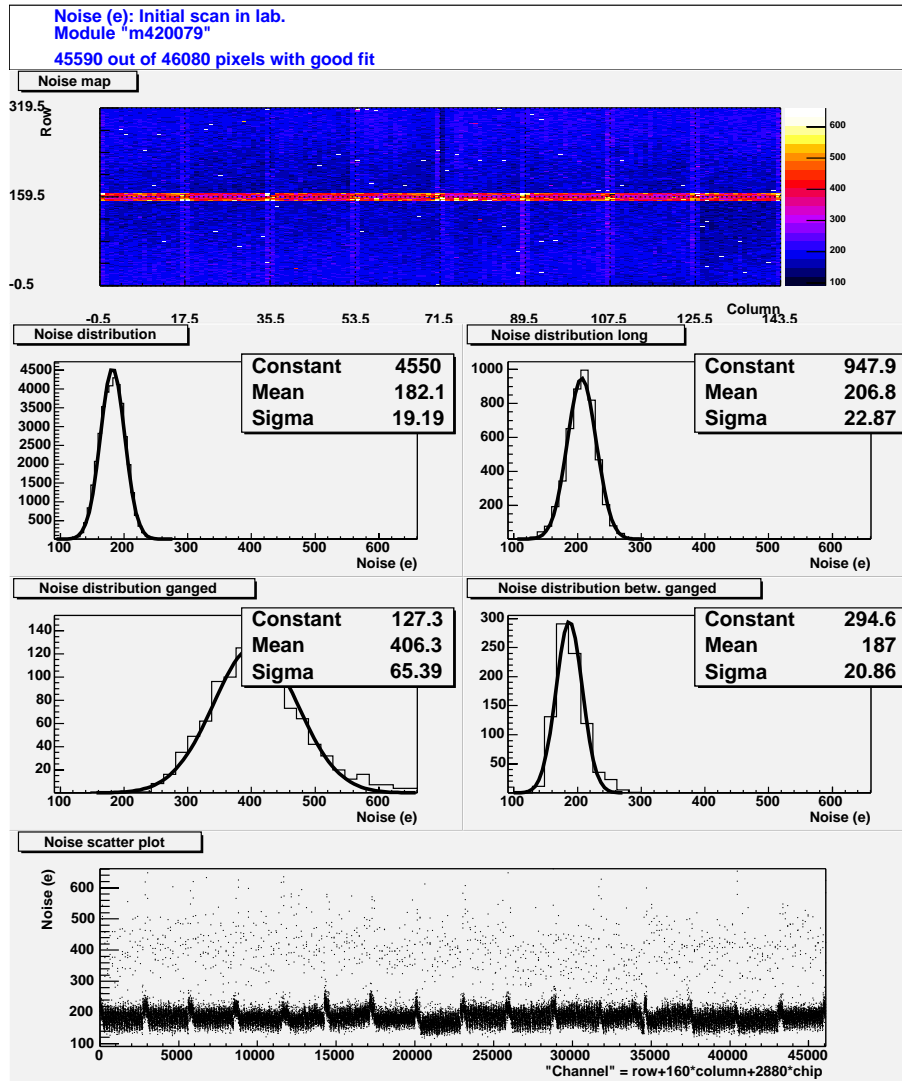
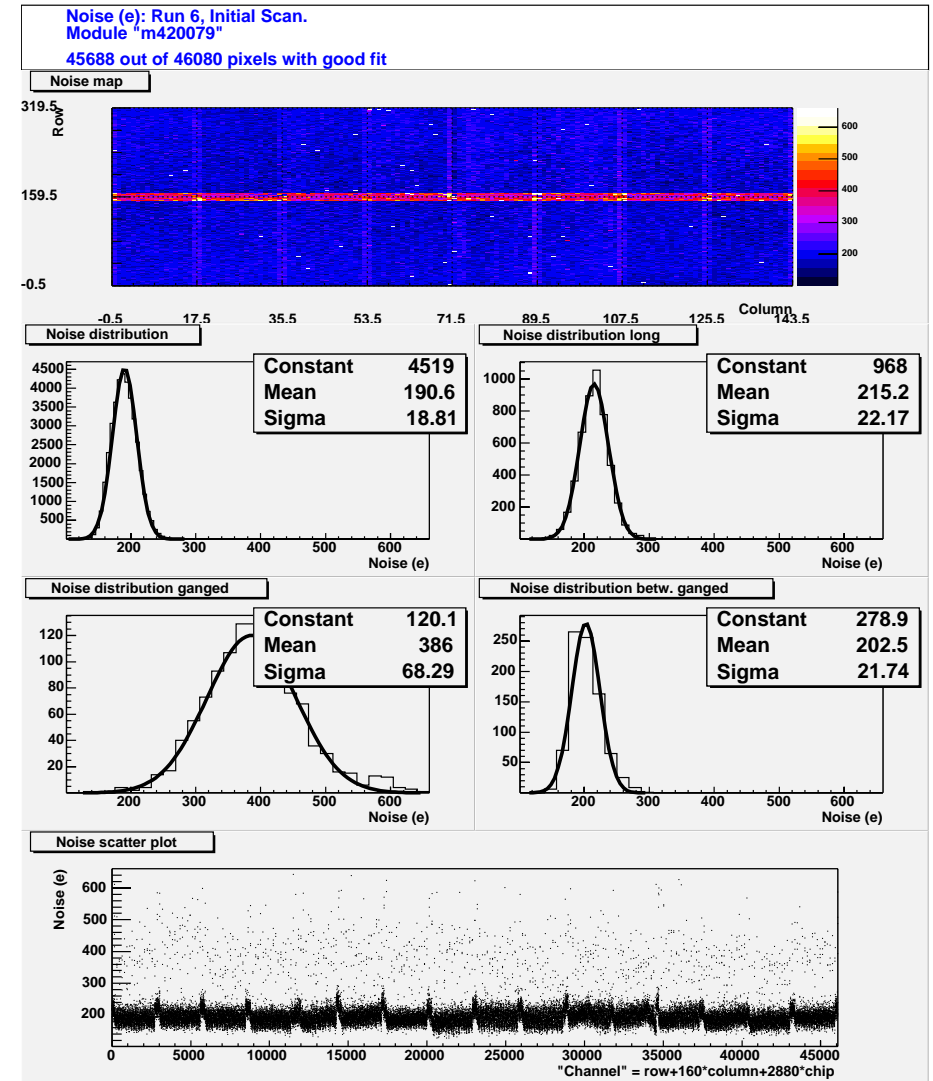
- Noise performance, once regulator oscillation was “cured” by using long input power cables, was almost identical to that in the lab (left in LBL lab, right installed in T7 at -7C). For example, normal pixels had mean 182e on left, 191e on right):

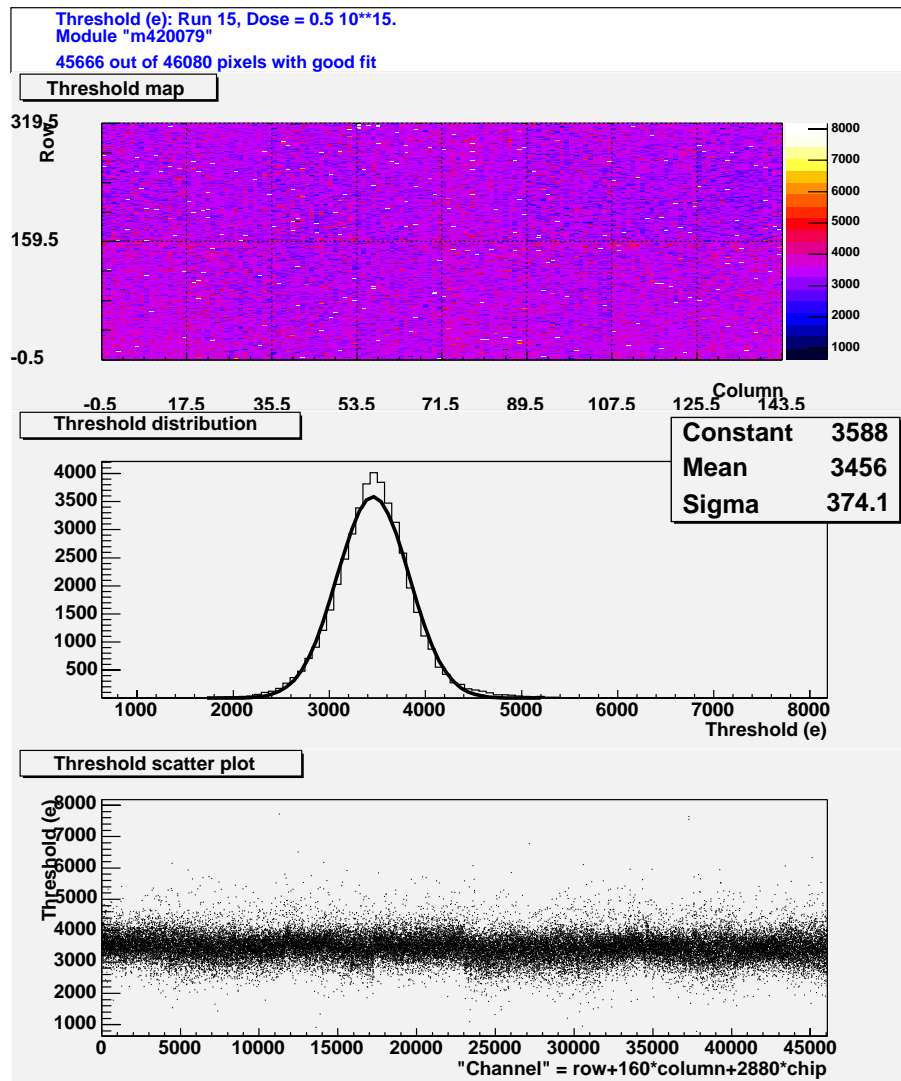
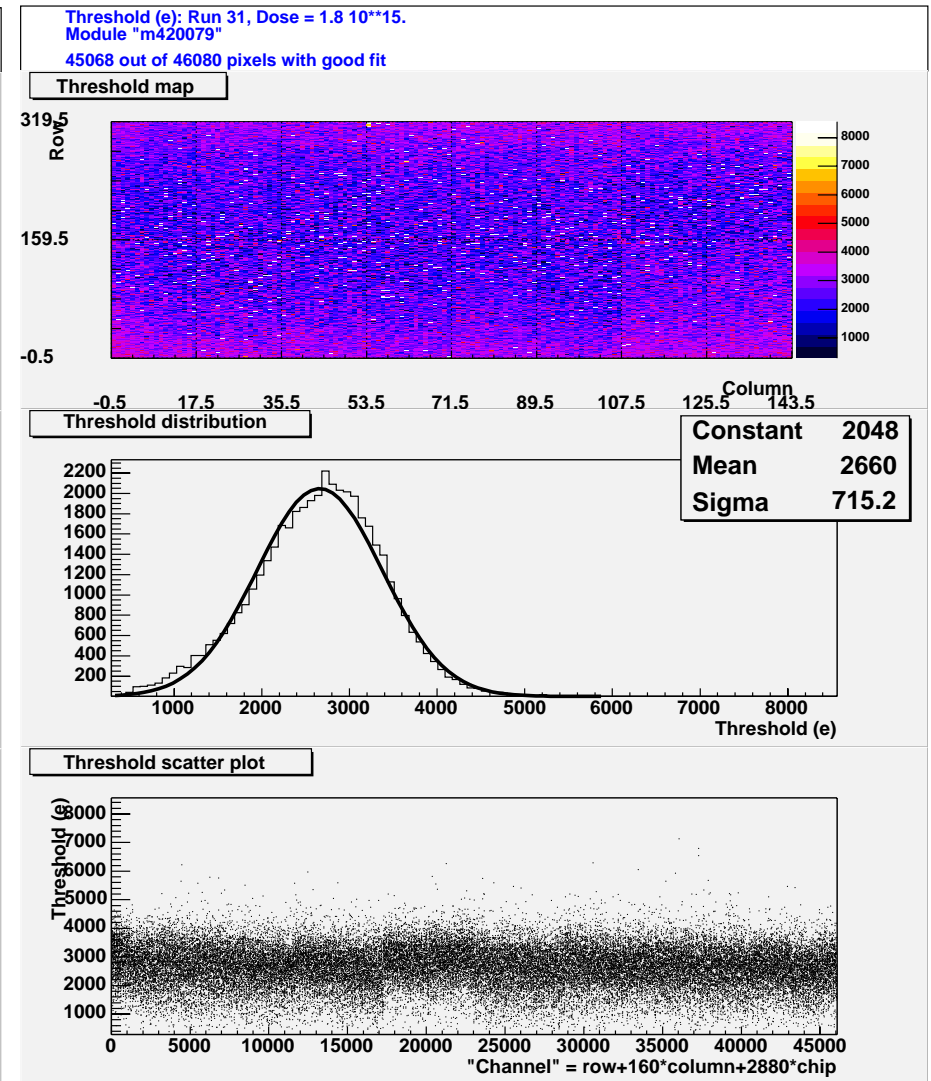
- Threshold dispersion increased with irradiation. Dosimetry at this time is just total SEC count. Estimate about 7MRad per 10^{15} protons seen by SEC, but real normalization awaits the measurements of Al foils. Left is than 3-4MRad, right is about 15MRad:

- Nominally, 10^{14} corresponds to about 0.8MRad at PS. A dispersion above about 300e starts to be a serious nuisance, and would almost certainly require re-tuning.
- Therefore, predict that re-tuning will be needed every 1-2 MRad, or about once every 1-2 weeks for the B-layer.

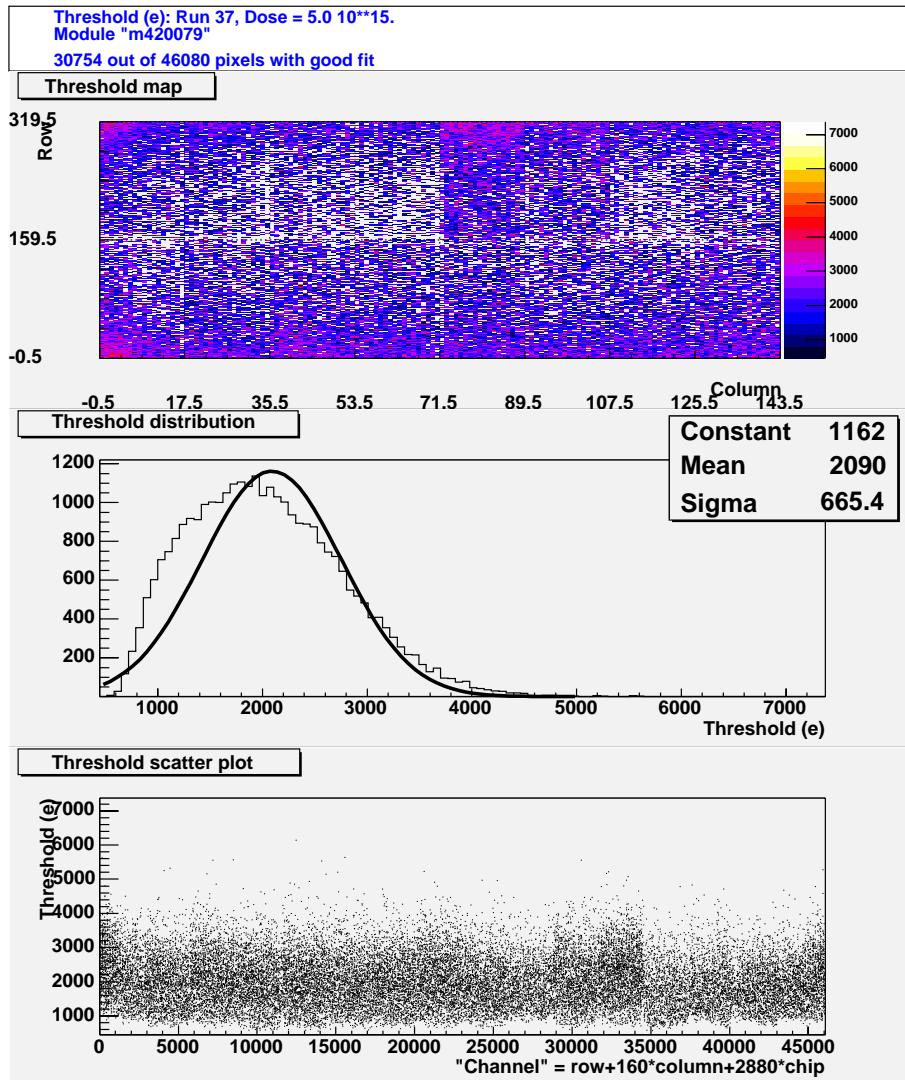
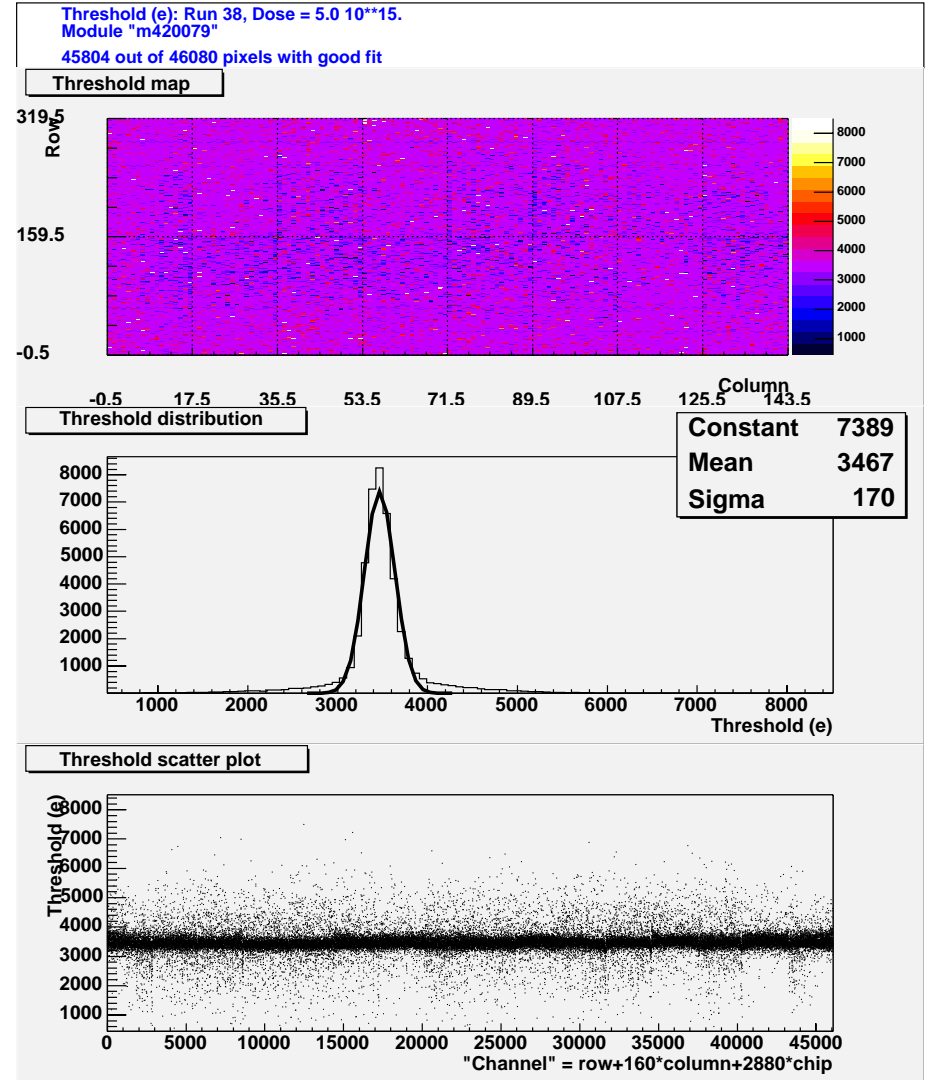
- After acquiring about half of the total dose (about 35MRad ?), two modules were chosen for re-tuning. One was GE_19 (new Tesla) and one was LBL_11 (CIS reference). The threshold distributions before and after re-tuning are shown here, and indicate that the re-tune should have been done with higher ITrimTh setting:

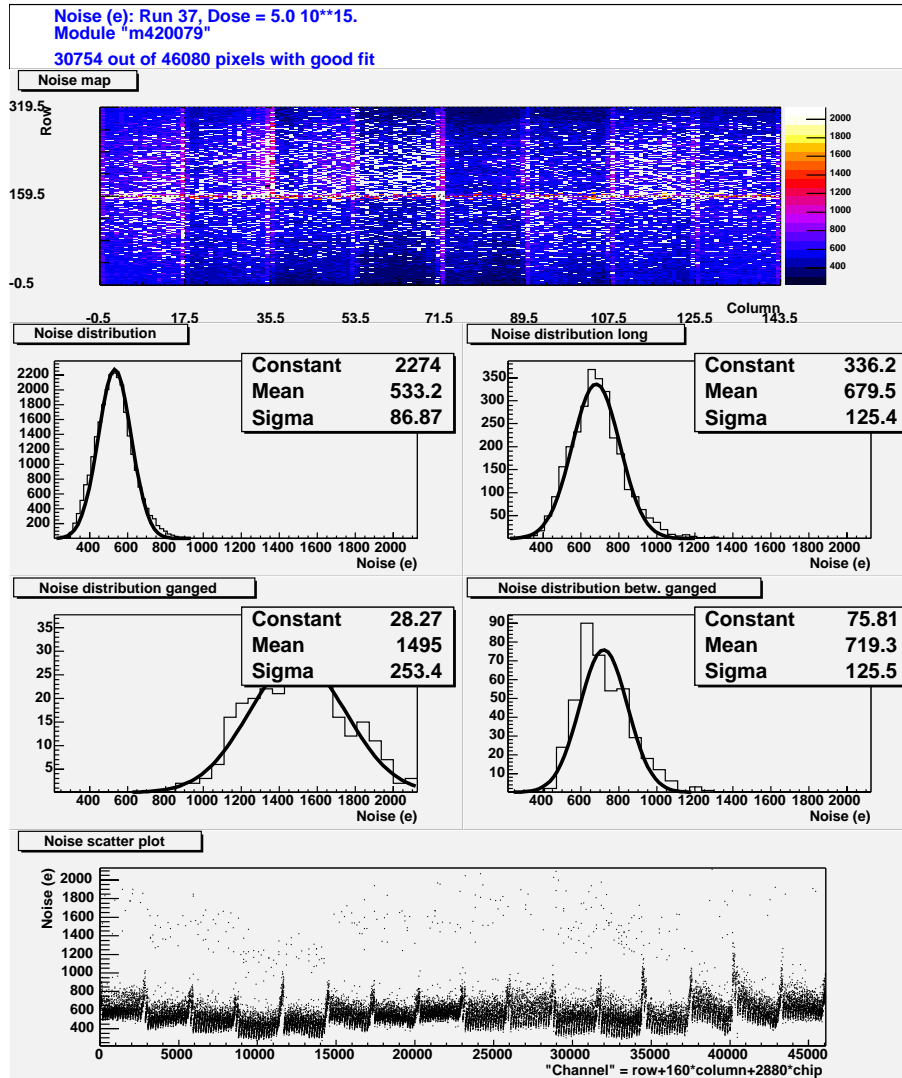
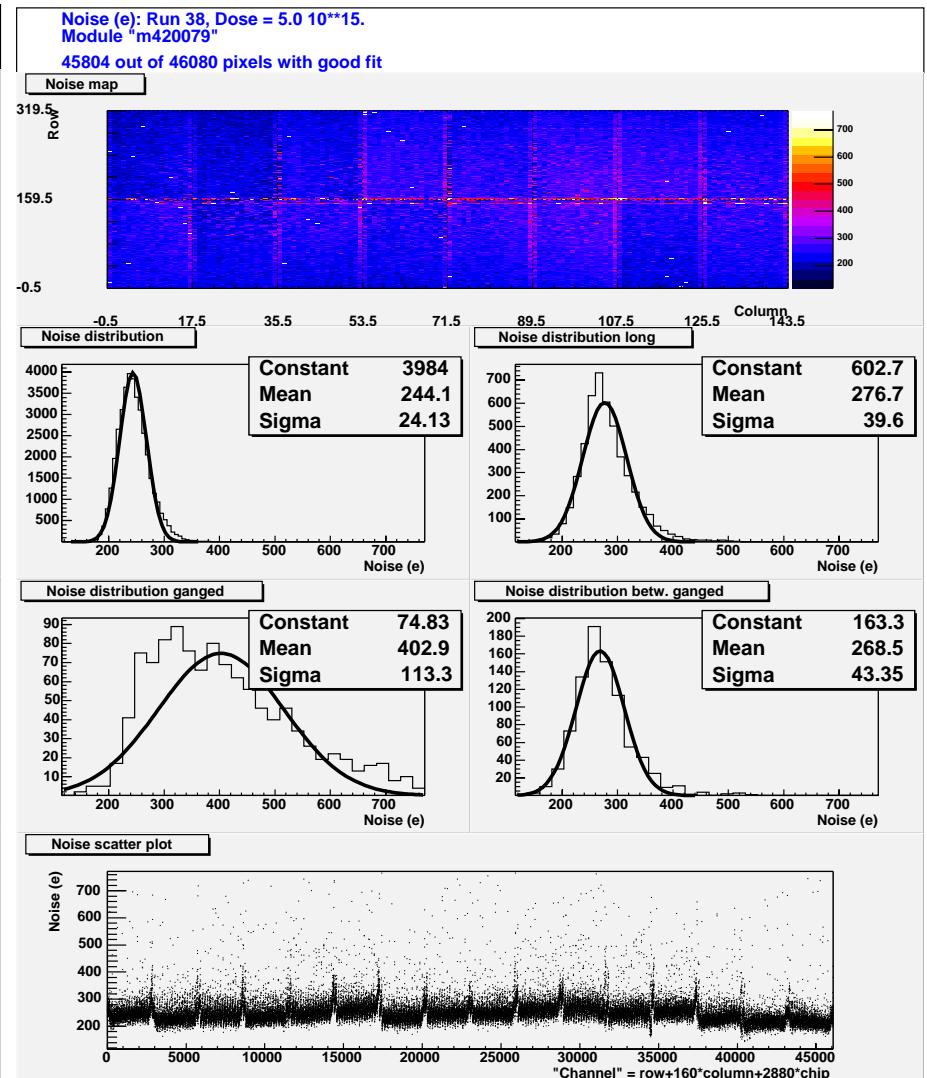
- Noise measurements with large threshold dispersion are essentially useless, but after tuning, noise measurement agrees with expectations after increase in leakage current (about 10-20nA per pixel):

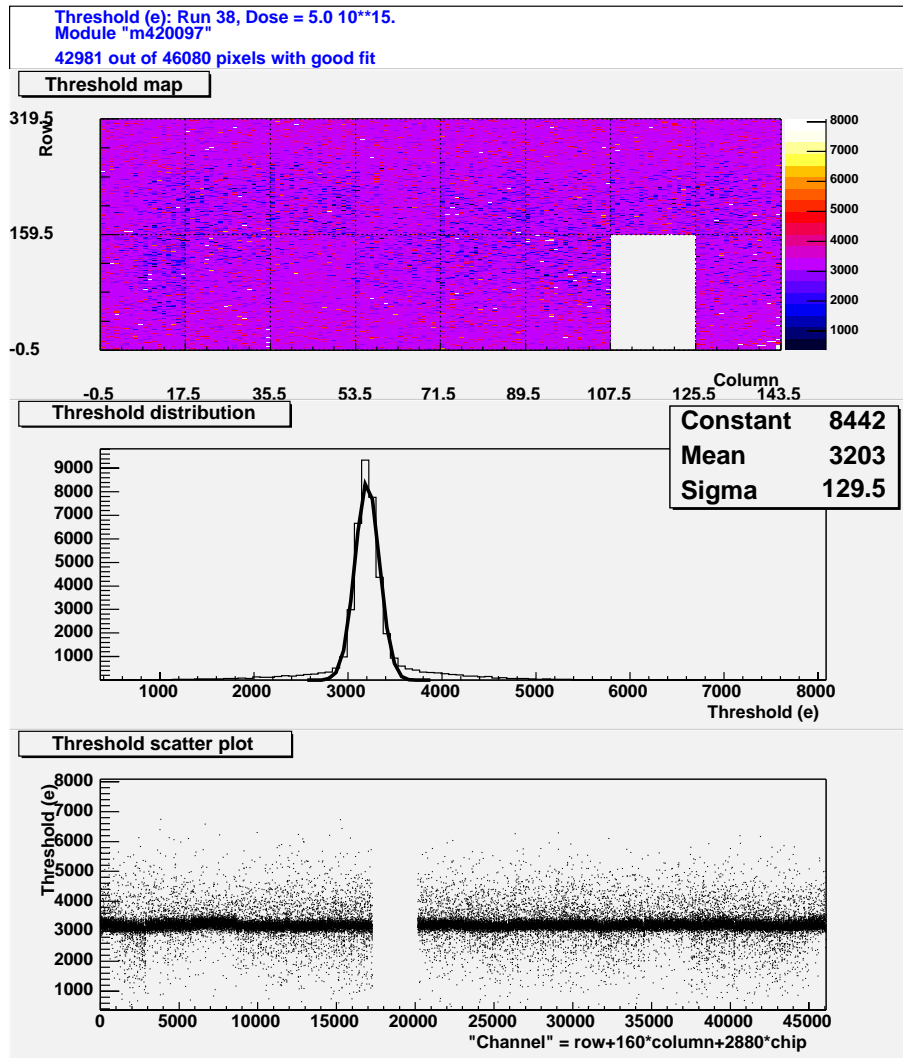
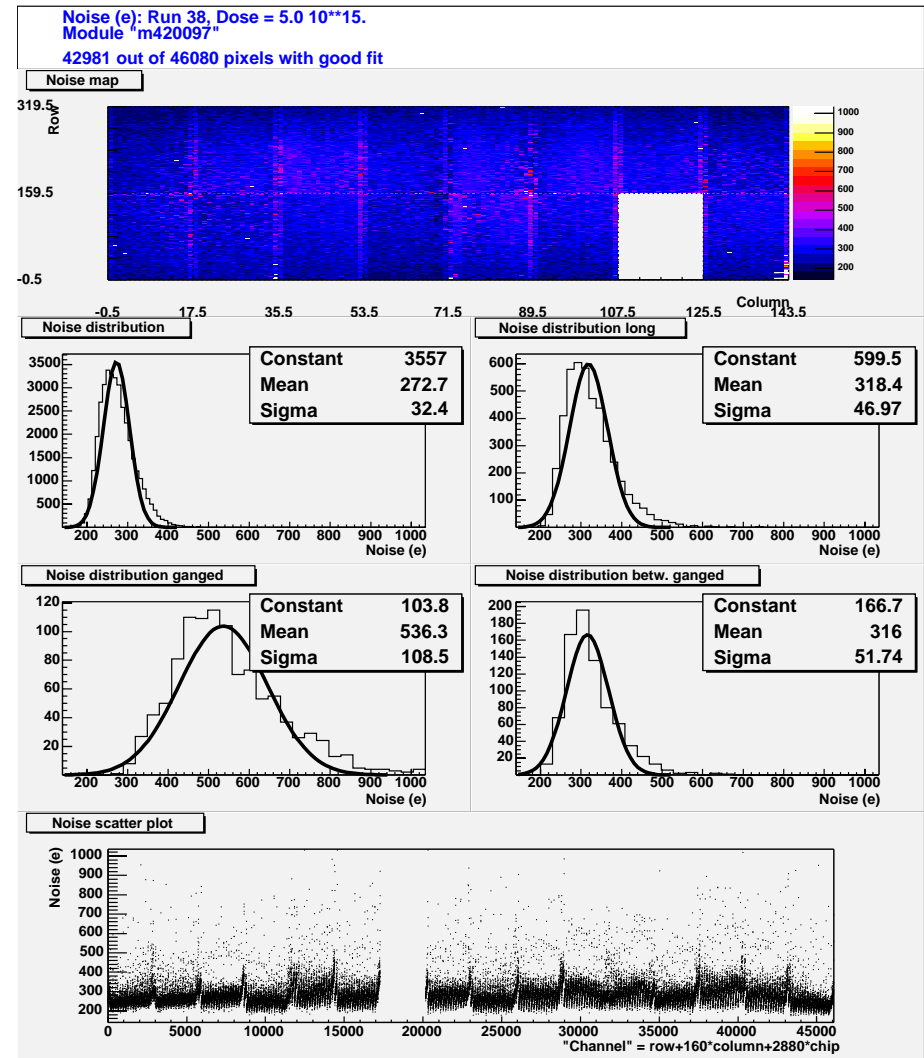
- Performance of GE_19 after re-tuning is very similar. Threshold retuned to similar dispersion with long tails due to small ITrimTh. Noise is similar, but slightly larger, than seen in IZM/CIS assembly. However, there is no sign of the very poor noise performance seen last year with irradiated Tesla:

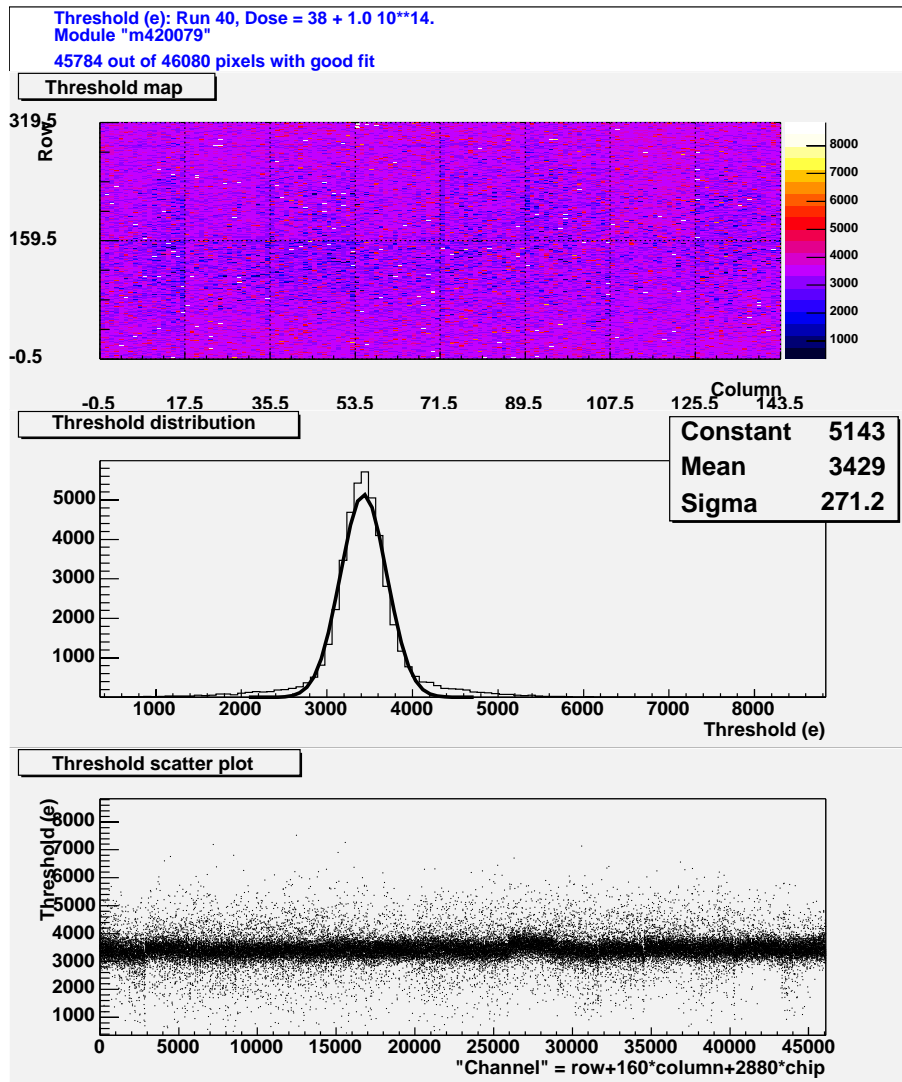
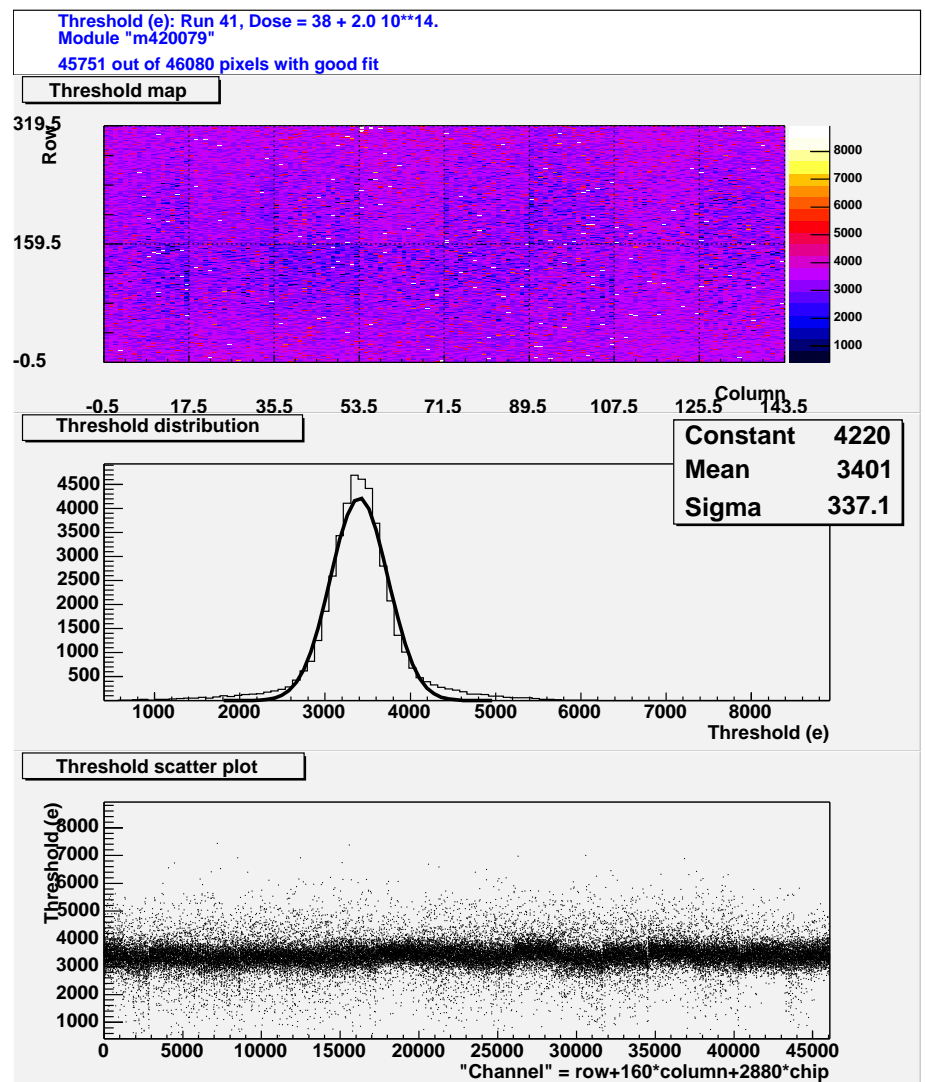
- Re-dispersion of the threshold happens quickly. As observed at LBL for FE-I1, re-dispersion does not depend on total dose, so similar effects are seen for initial irradiation and continued irradiation after large dose. Left plots are for about 1MRad increment and right plots are for about 2MRad increment after retuning:

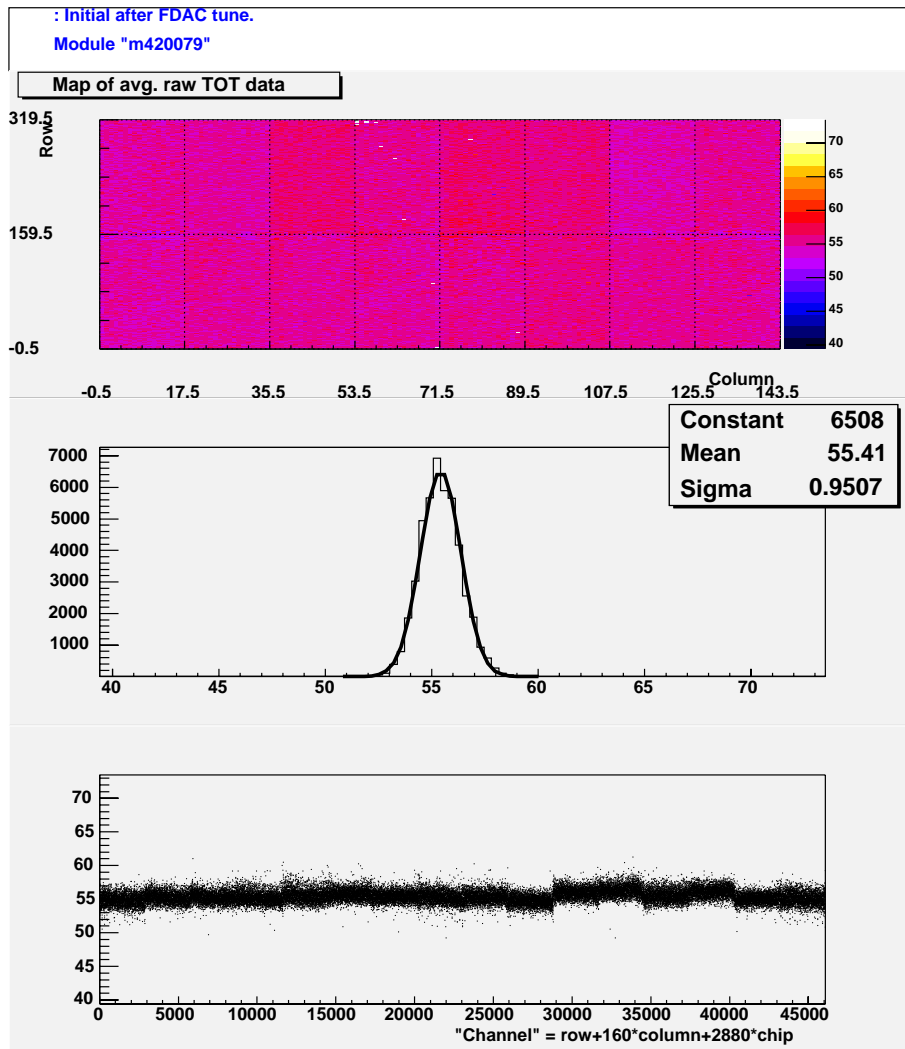
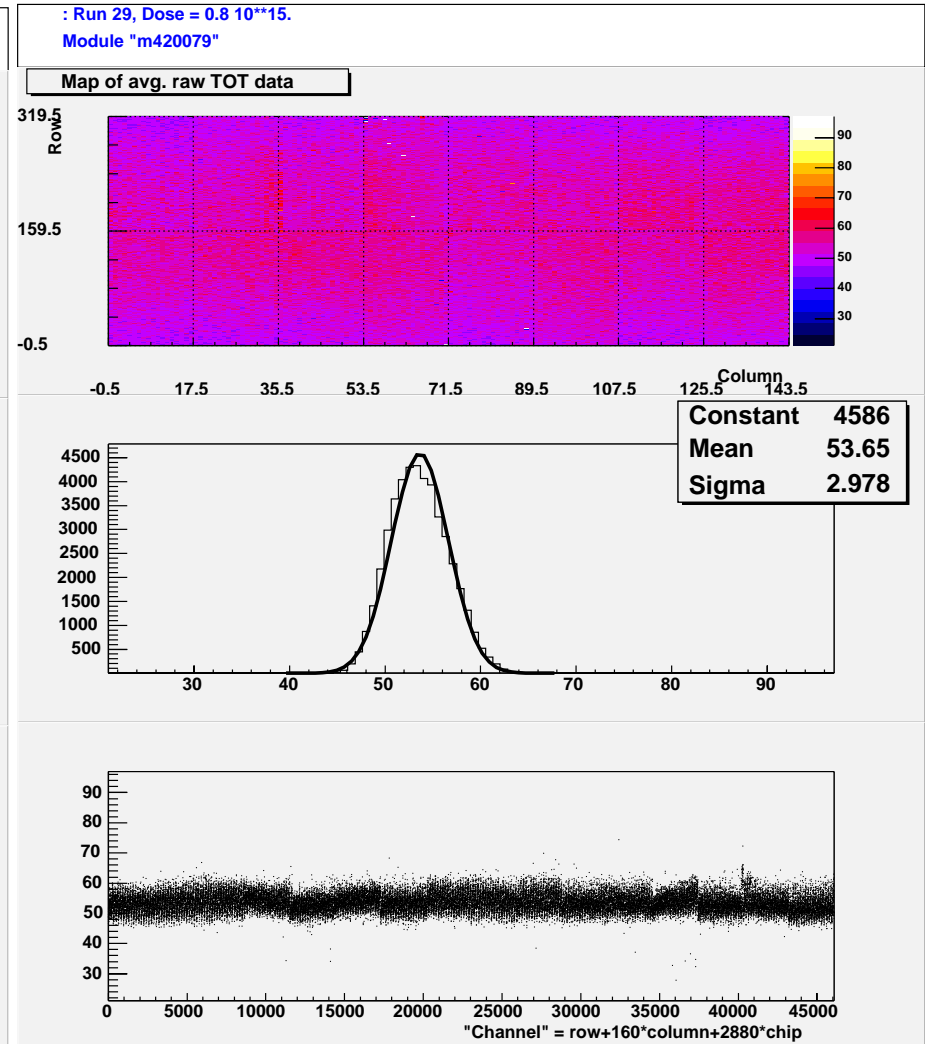
Look at LBL_11, for which FDACs were tuned to give mean TOT about 55 for 20Ke. Use injection of 25 events with 20Ke to study evolution of TOT performance with dose. Initial dispersion of 2% increases to about 6% after dose of about 5MRad.

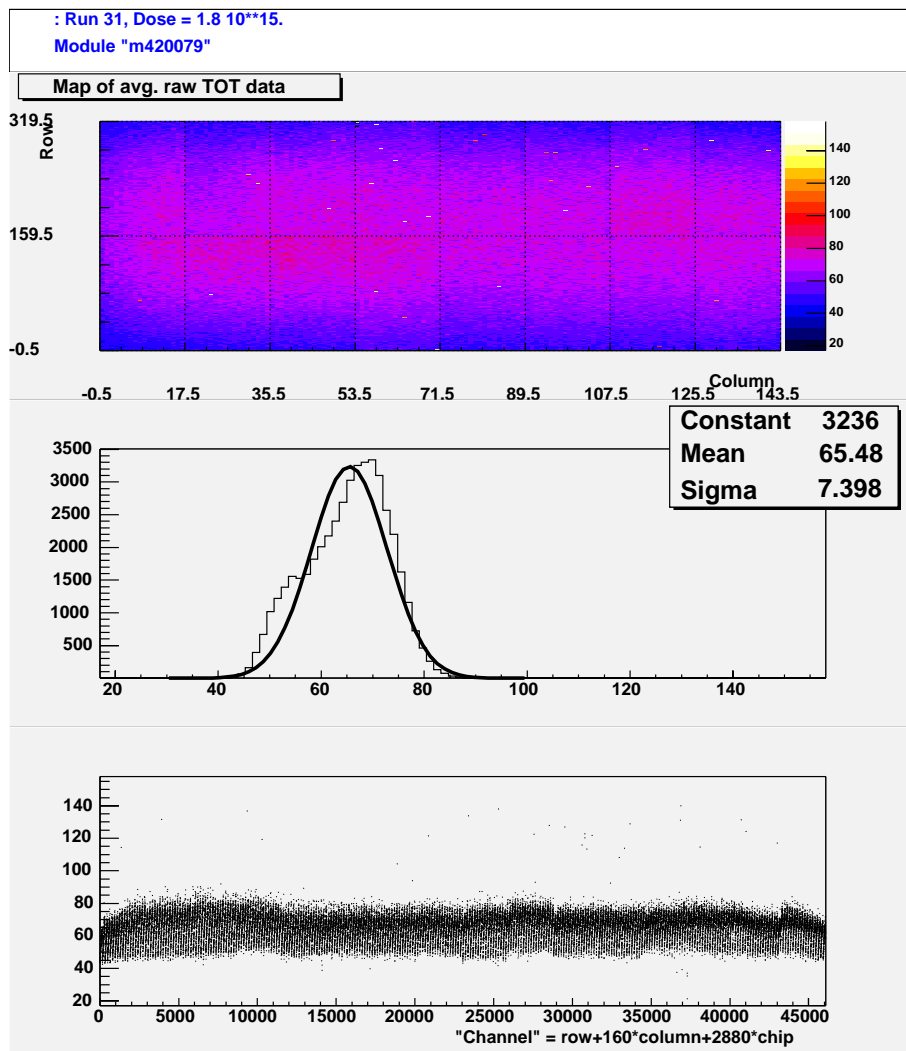
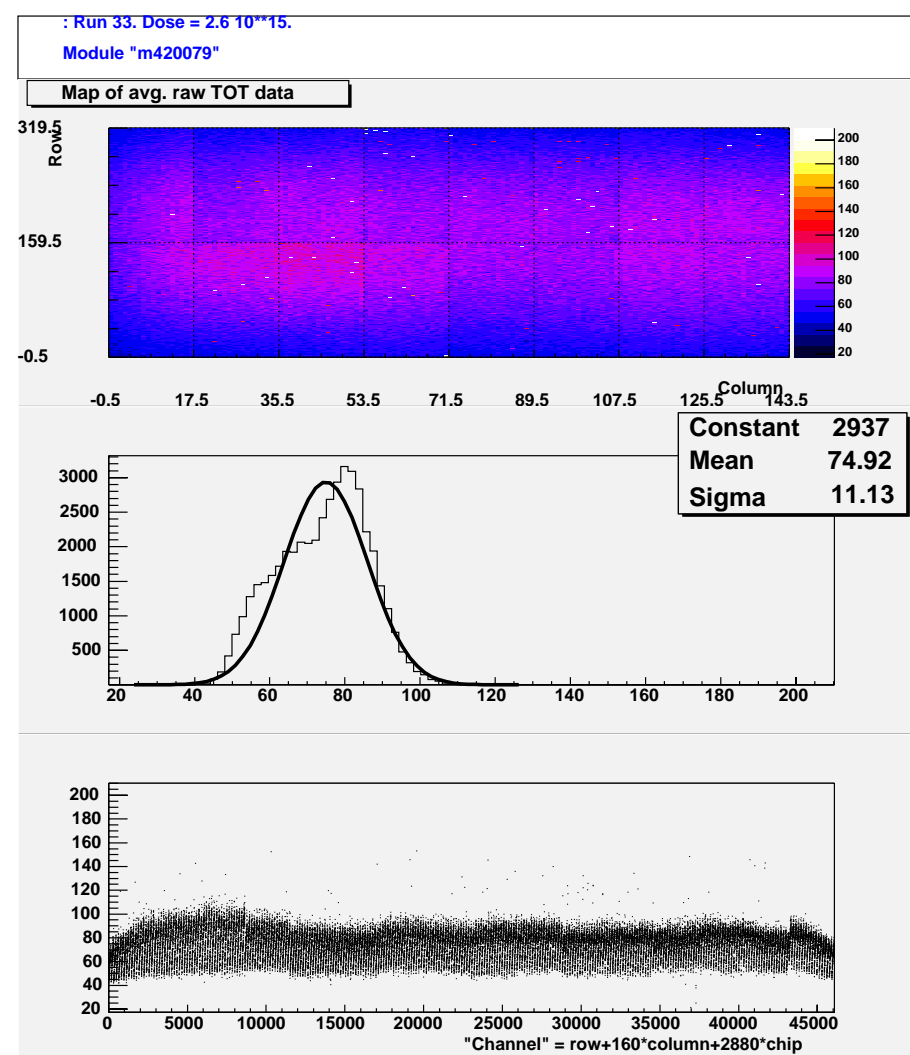
As dose continues to increase, begin to see sudden increase in TOT in high dose regions of module. Left plot is for about 14MRad, right plot is about 18MRad. TOT dispersion occurs more slowly with dose than threshold dispersion, but would still want to retune every 5-10MRad in order to avoid problems:

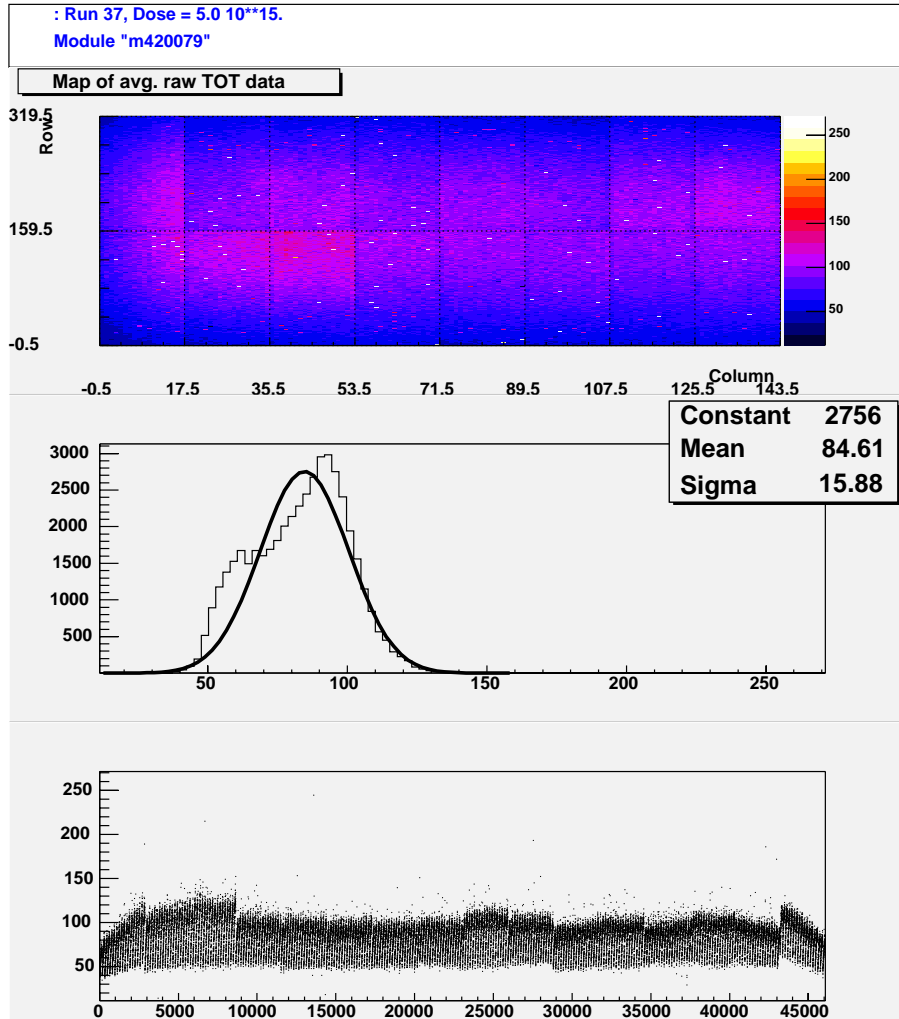
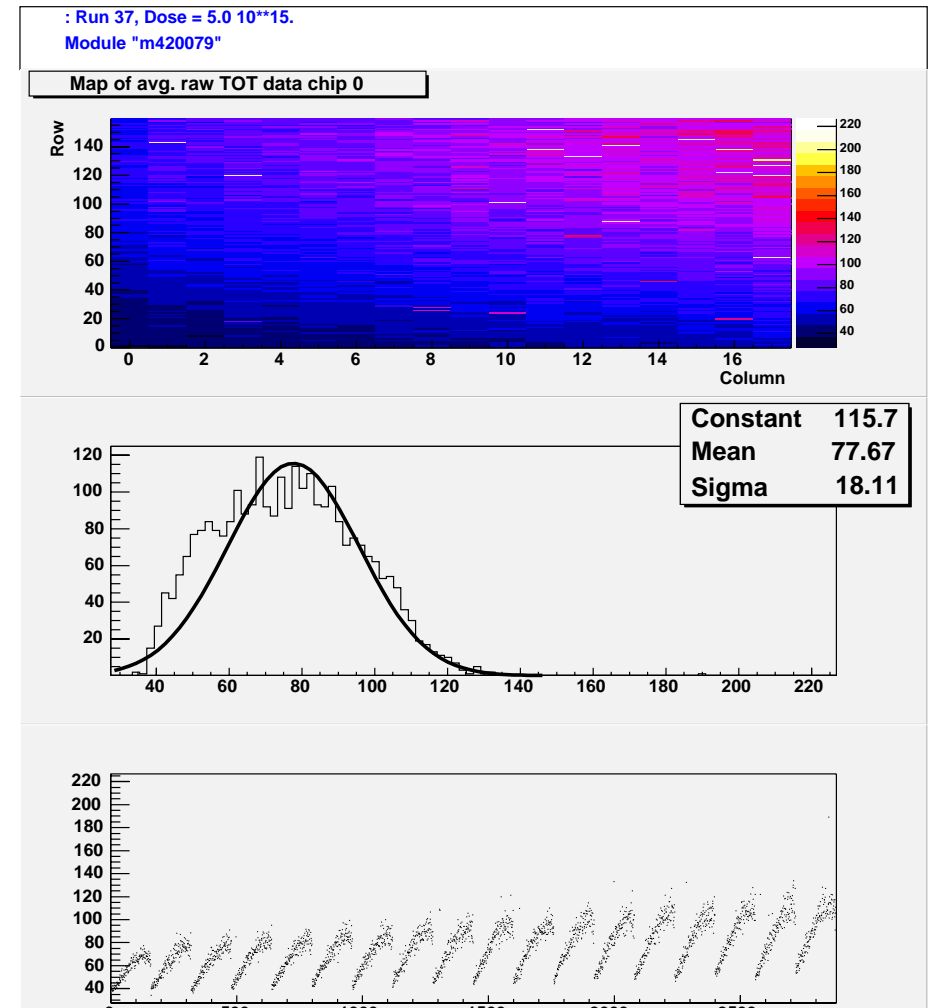
- Plot of TOT behavior just before threshold re-tune. Show expanded plot for a single chip as well to indicate large variations due to dose. TOT range for 20Ke is 40 - 100 counts. Plots correspond to dose of about 35MRad:

- Initial experience with re-tuning of FDACs suggests that the DAC range may not be adequate after irradiation. Further study needed in lab.

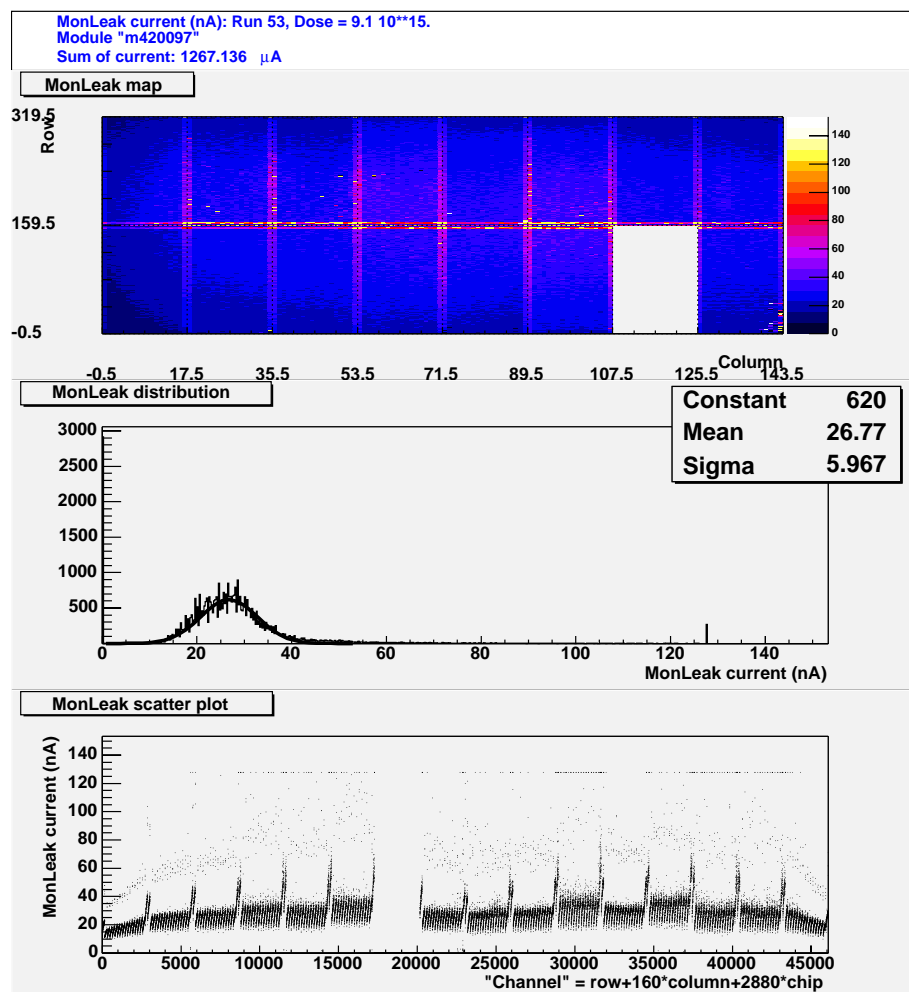
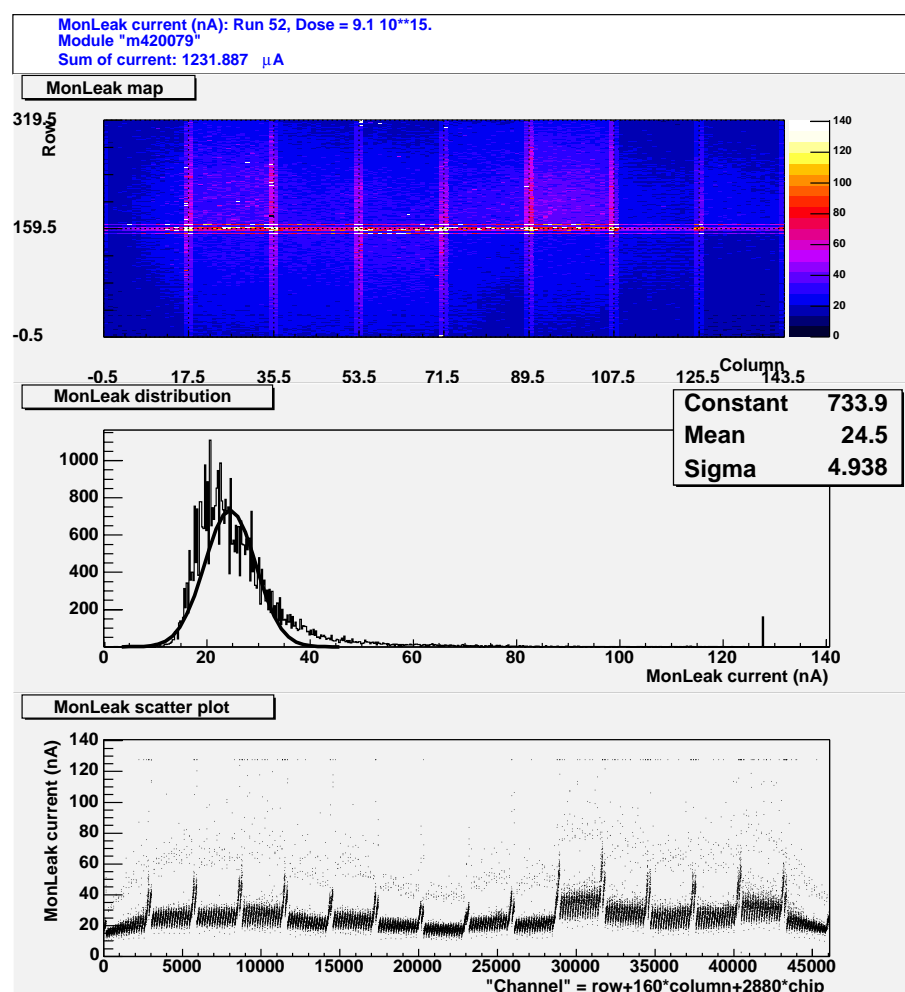
Plot Monleak current for two modules (GE_19 and LBL_11) at end of irradiation period. Very non-uniform dose is apparent, due to lack of 2D scanning hardware. Additional non-uniformities arise from modest temperature stability during roughly 15 minute MonLeak scan (NTC recorded each chip during scan, see +/- 1-2C variations).
